OSWEGO RIVER BASIN ONEIDA CITY RESERVOIR DAM

ONEIDA COUNTY, NEW YORK
INVENTORY NUMBER NY 421

PHASE 1 INSPECTION REPORT NATIONAL DAM SAFETY PROGRAM

**PHASE 1
INSPECTION REPORT
NATIONAL DAM
SAFETY PROGRAM**

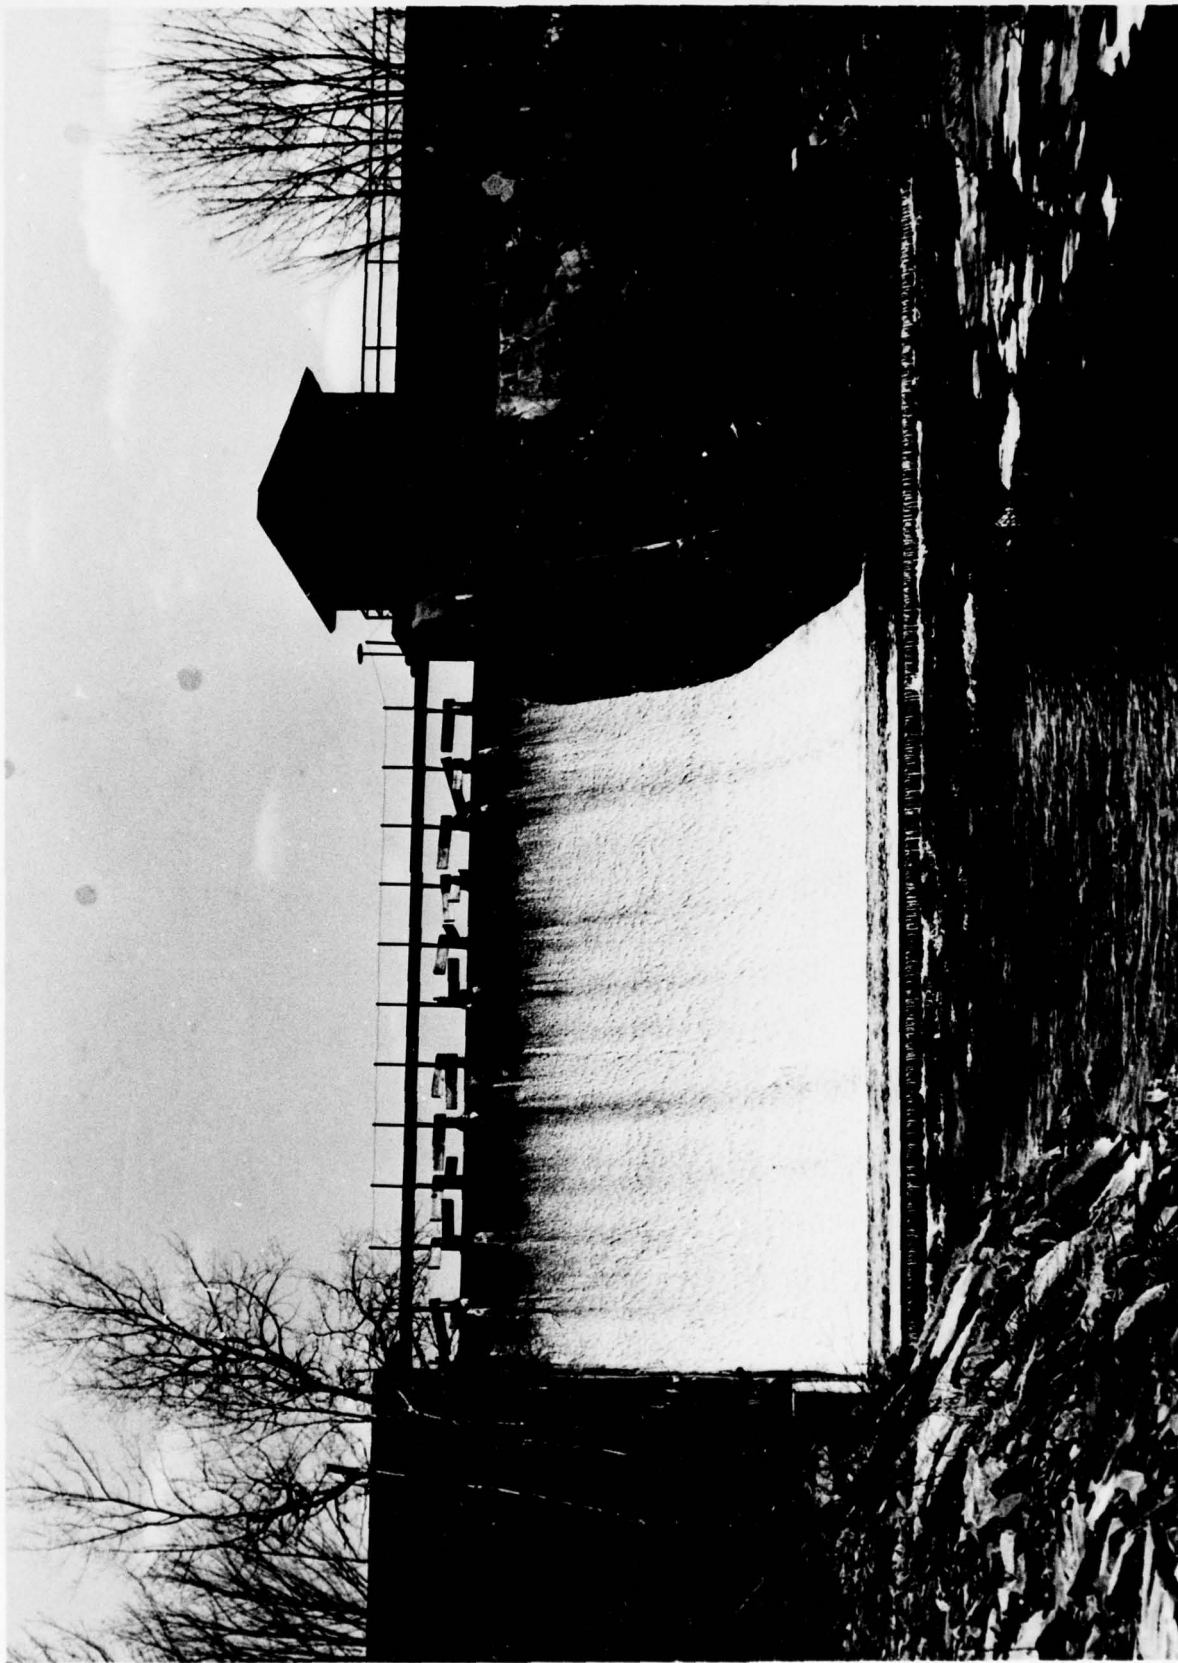
PLATE 1

1. Overall view of dam from downstream

Visible: Overflow and non-overflow dam sections, flashboards, stilling basin, gate house, drain pipe discharge in stilling basin left wall.

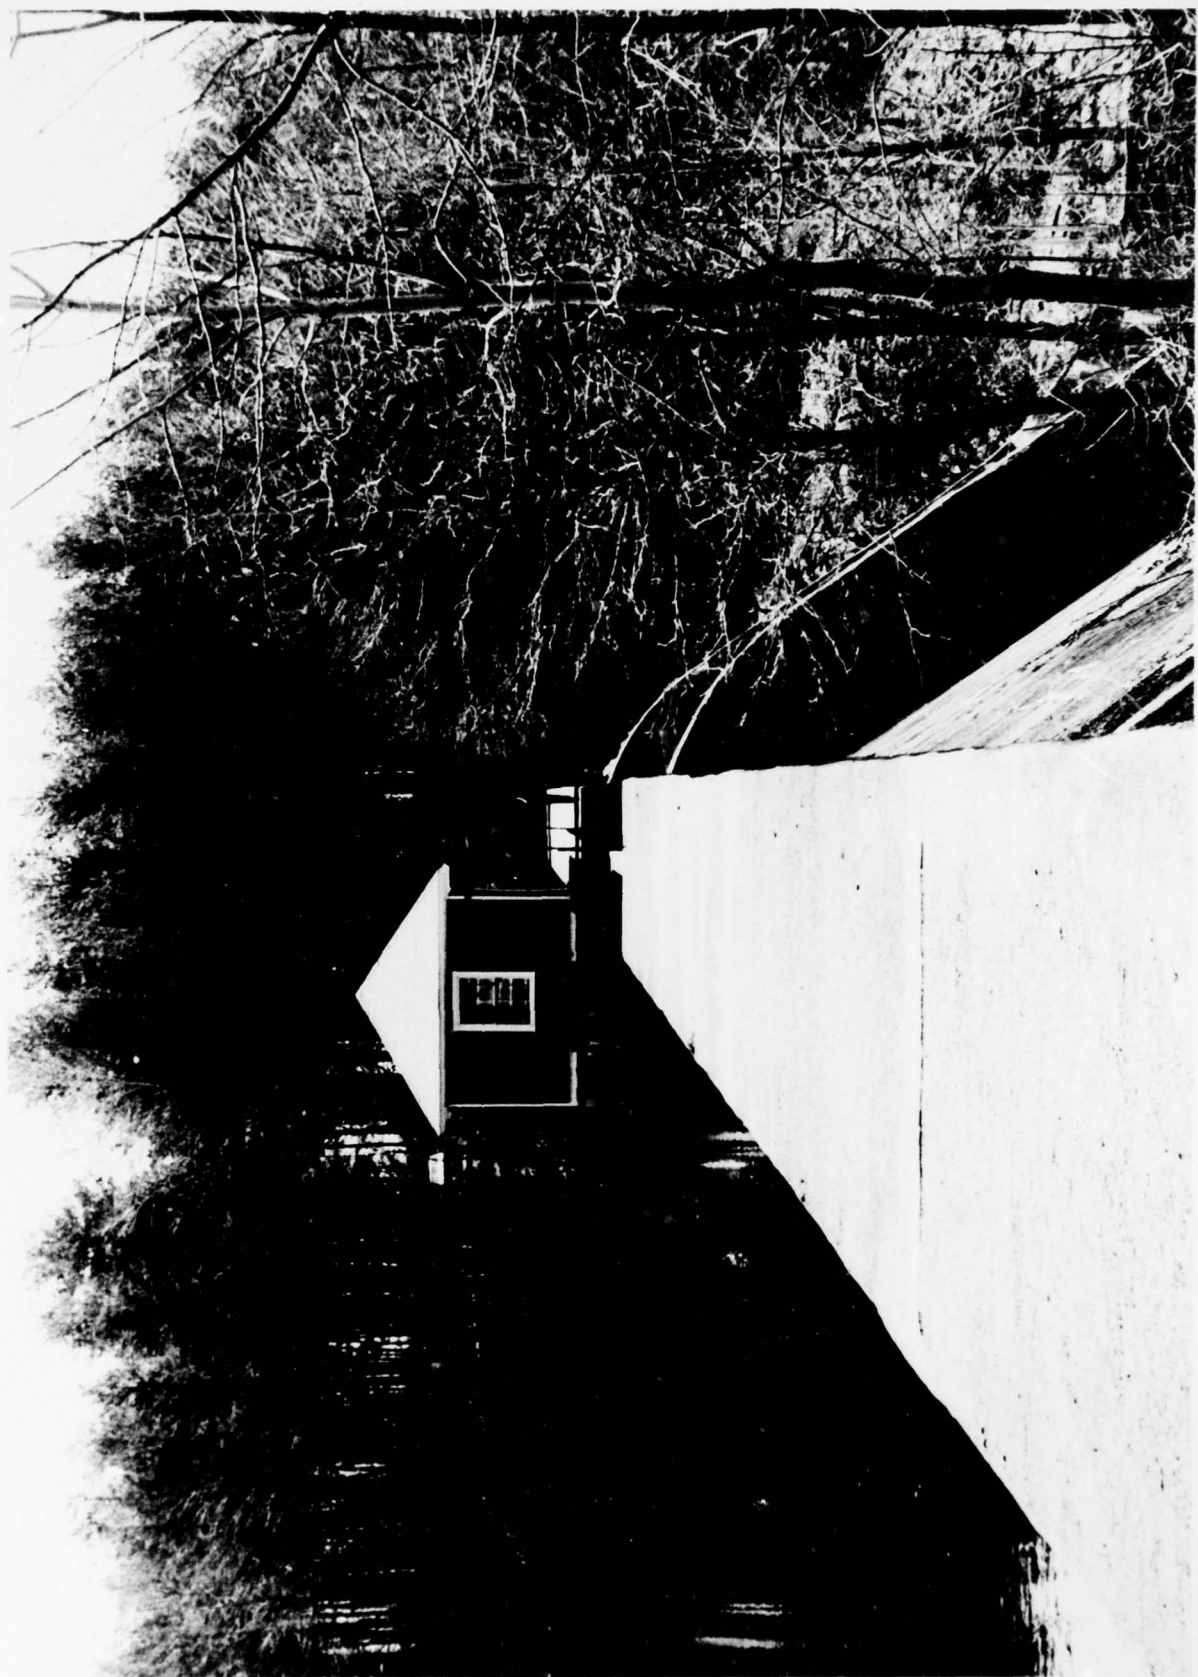
PLATE 2

2. View from right abutment

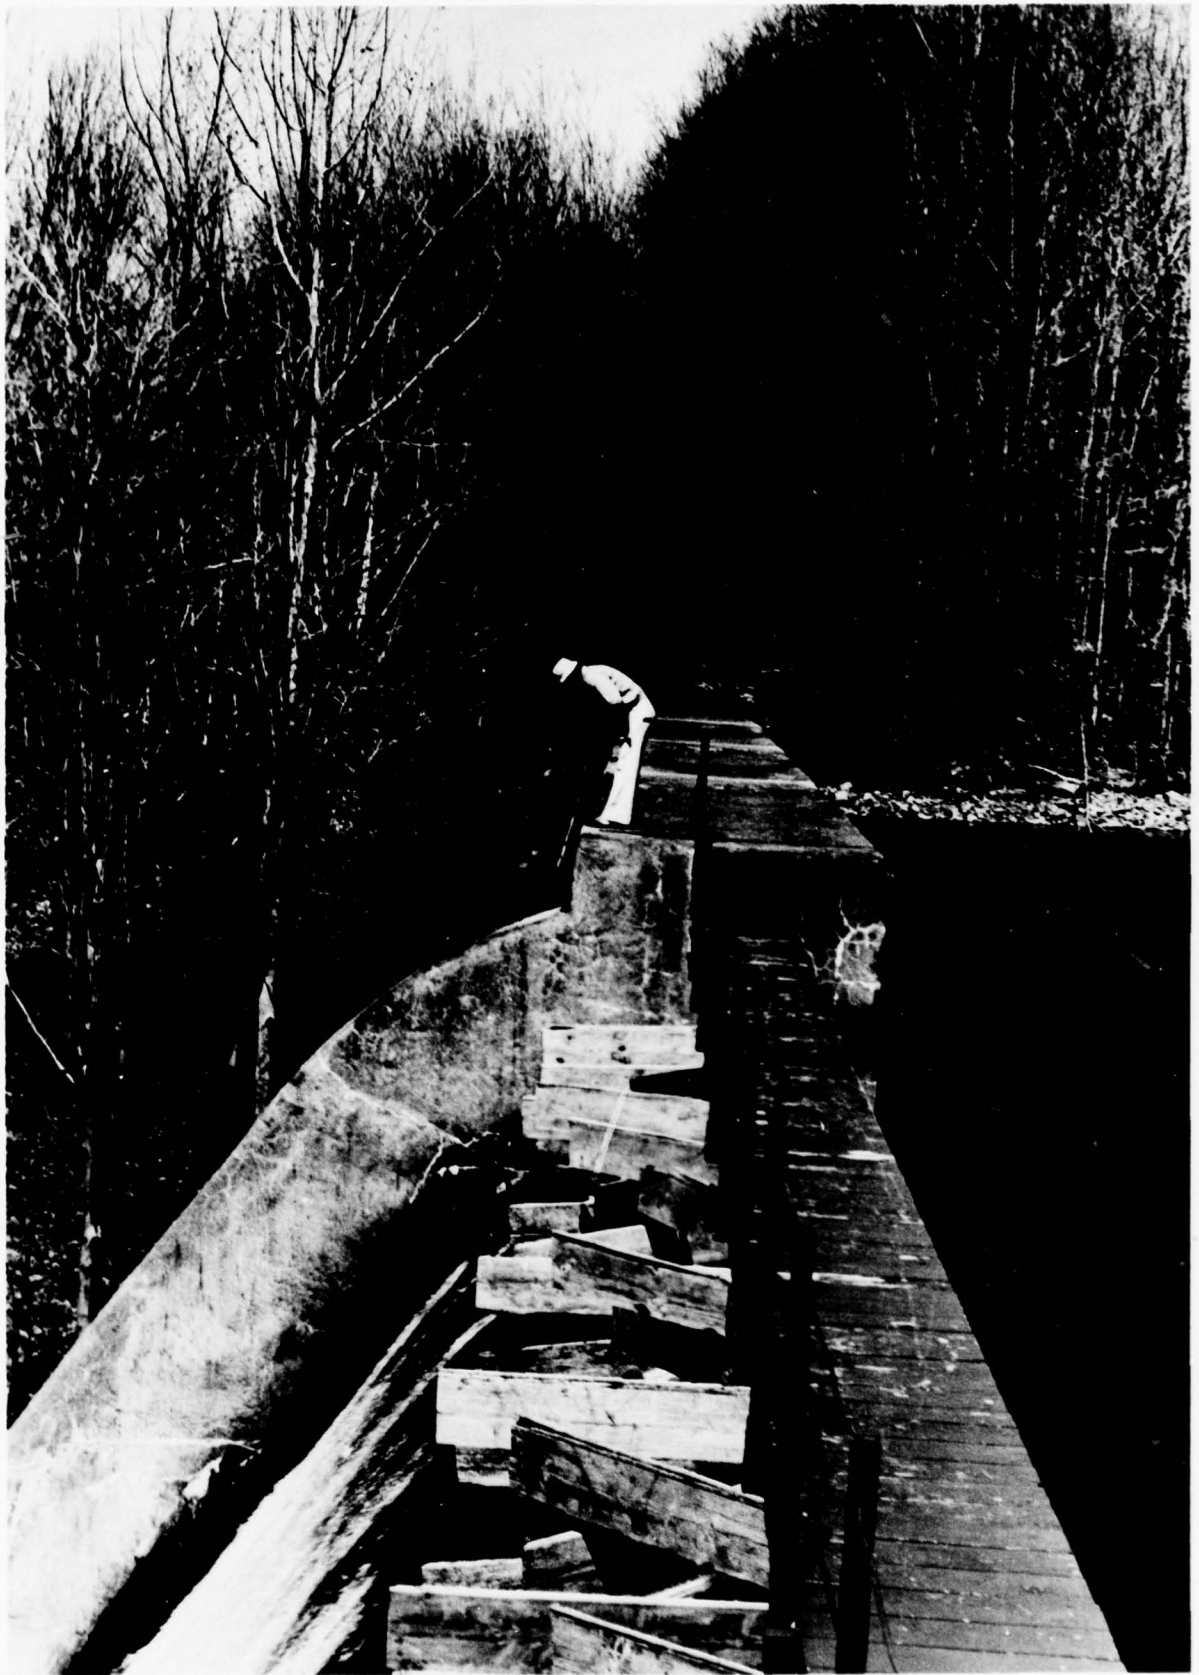
PLATE 3

3. View from left of spillway showing right abutment and flashboards.

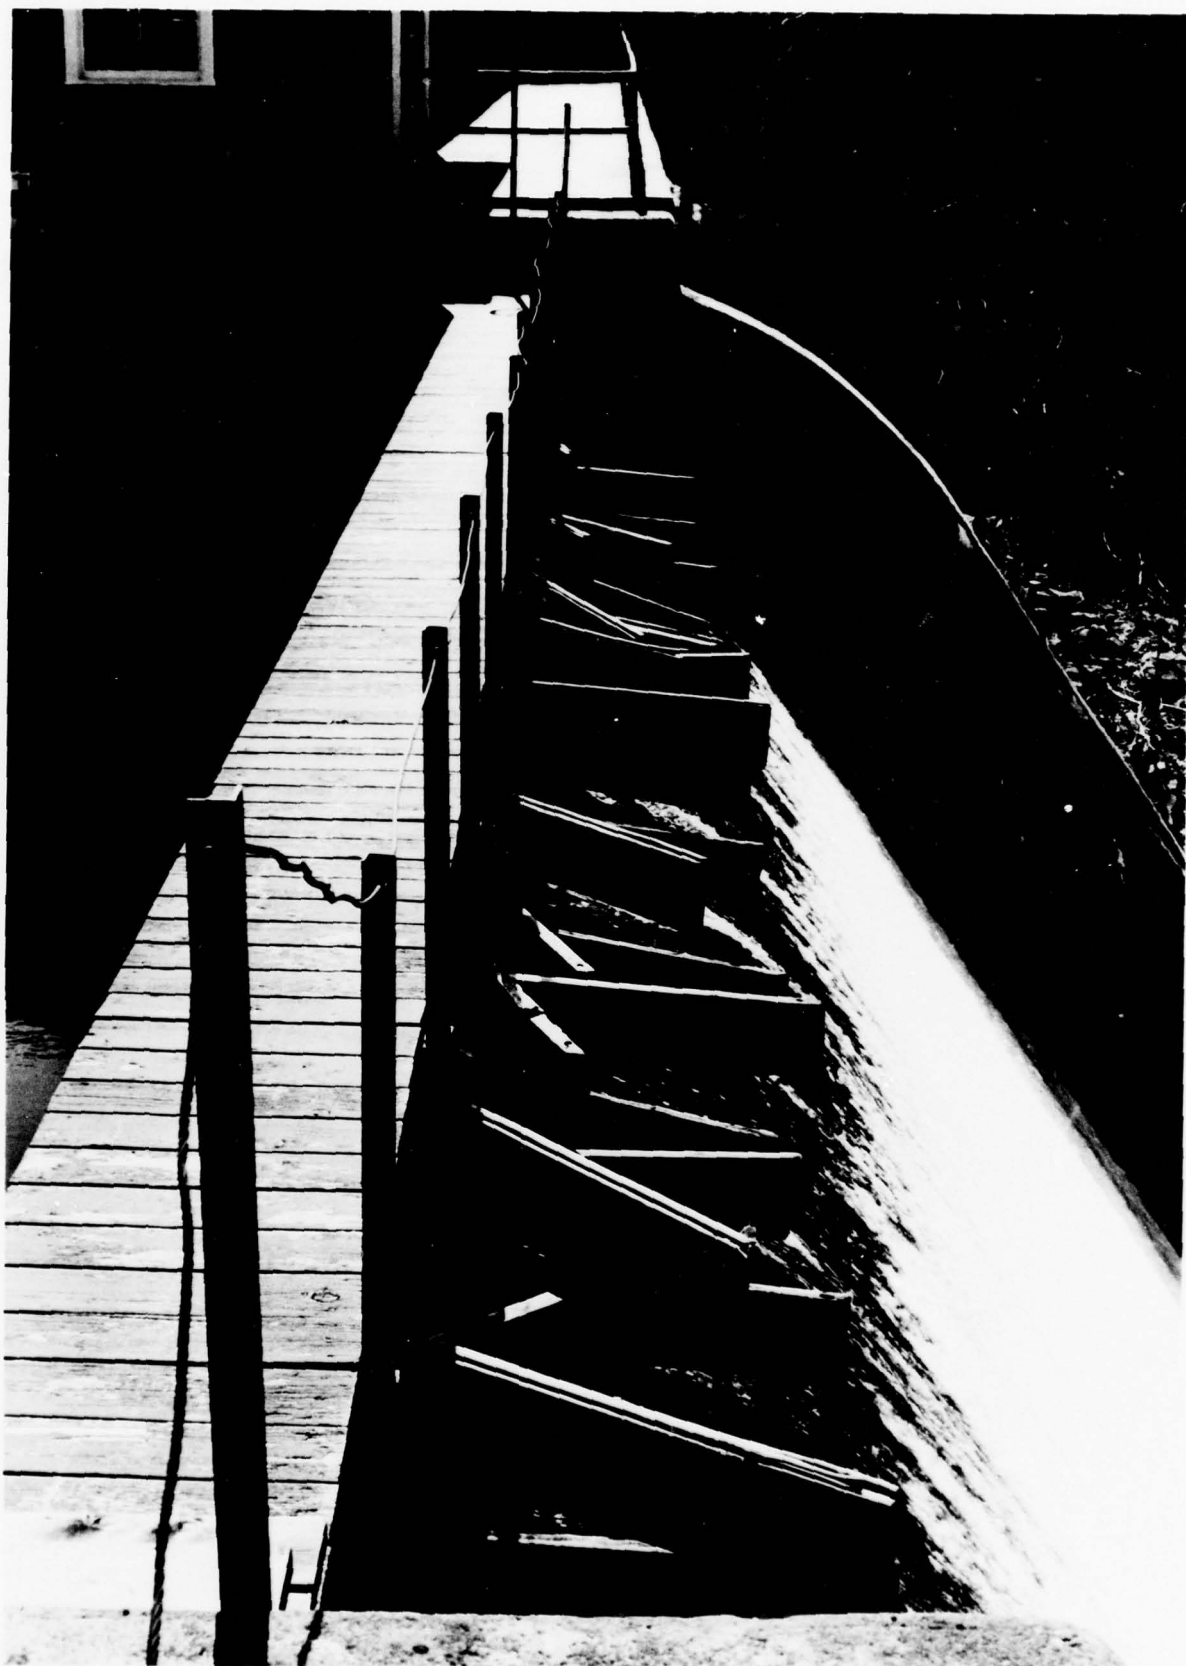
PLATE 4

4. View from right of spillway showing flashboards and manwalk.

Note: Location below top of dam and control valve for opening flashboards.

1. The flashboards should remain open and, as soon as practical, the flashboards and man walk should be removed. Replacement of the flashboards or gates should be considered only after completion of stability analysis.
2. Remedial modifications should be made within the next two years to increase the storm storage and/or spillway capacity if the structural stability is inadequate based on the high water level (PMF).

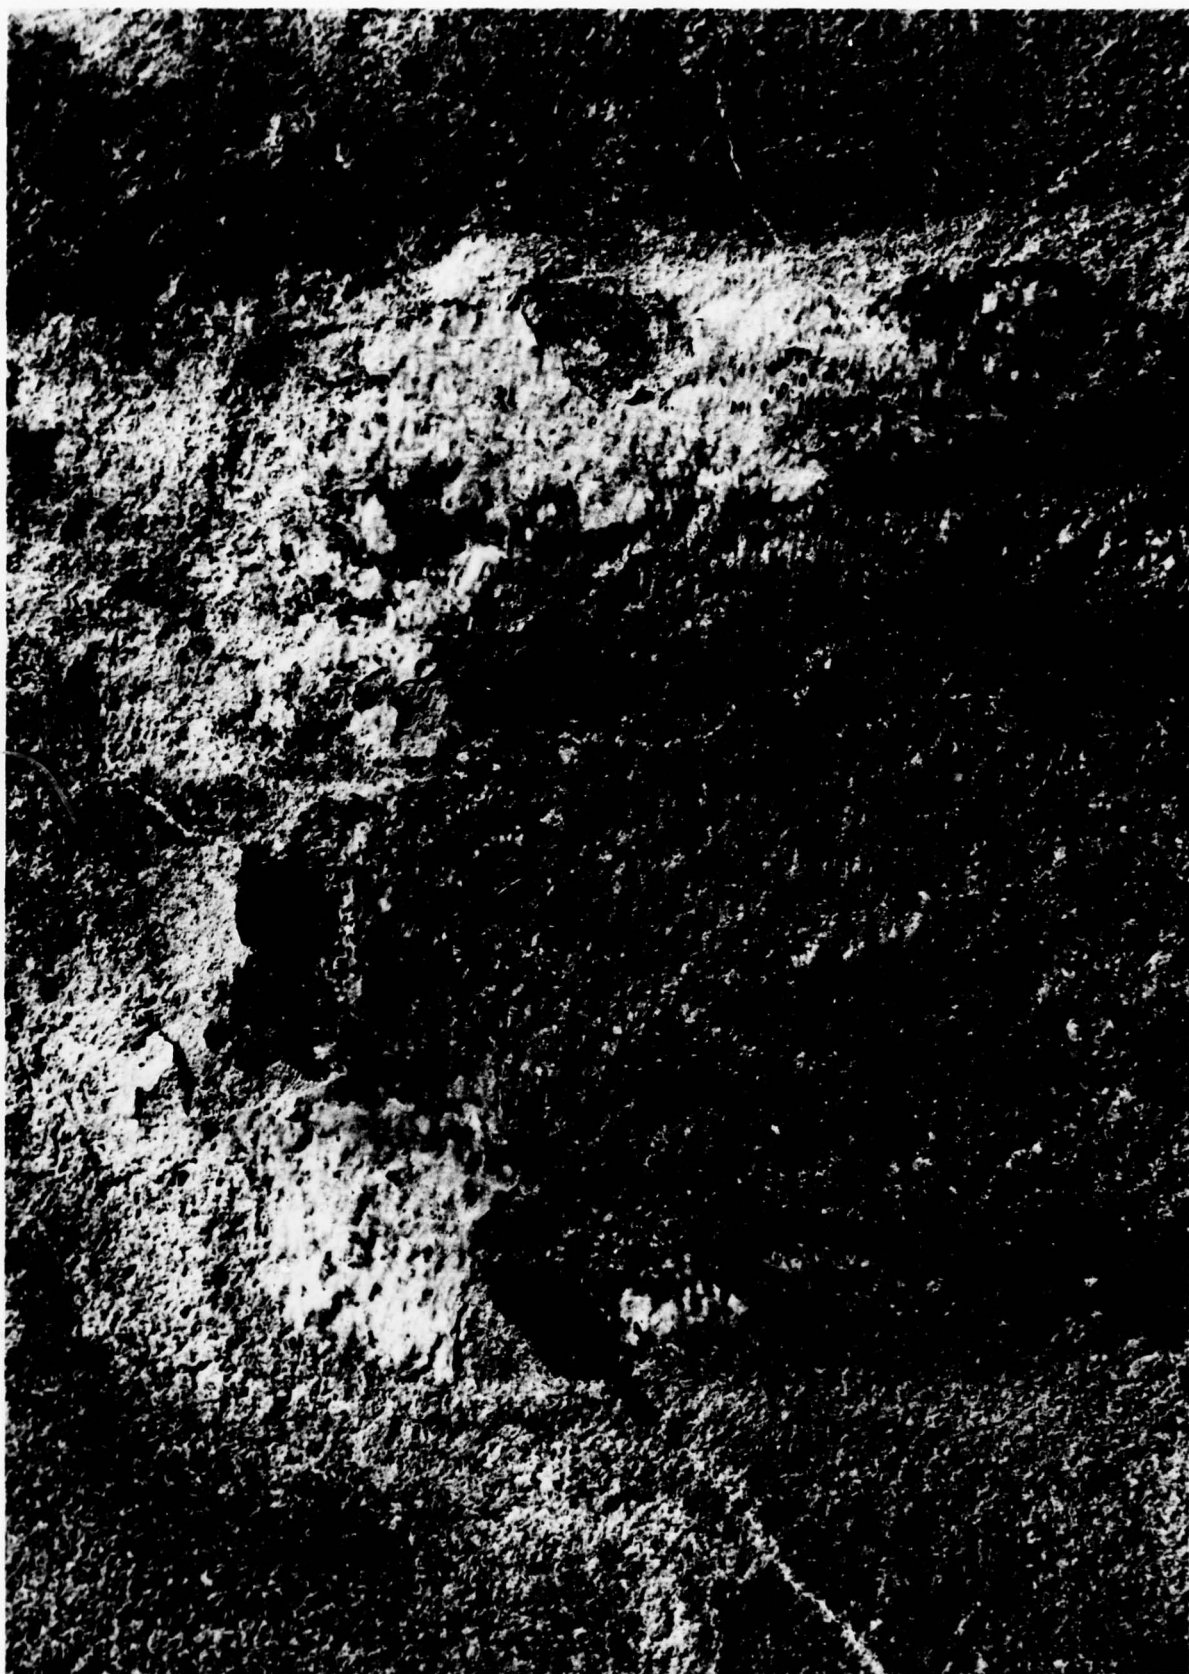
PLATE 7

7. Close up of dam (left section) showing build up of calcium carbonate due to seepage, seepage as shown.

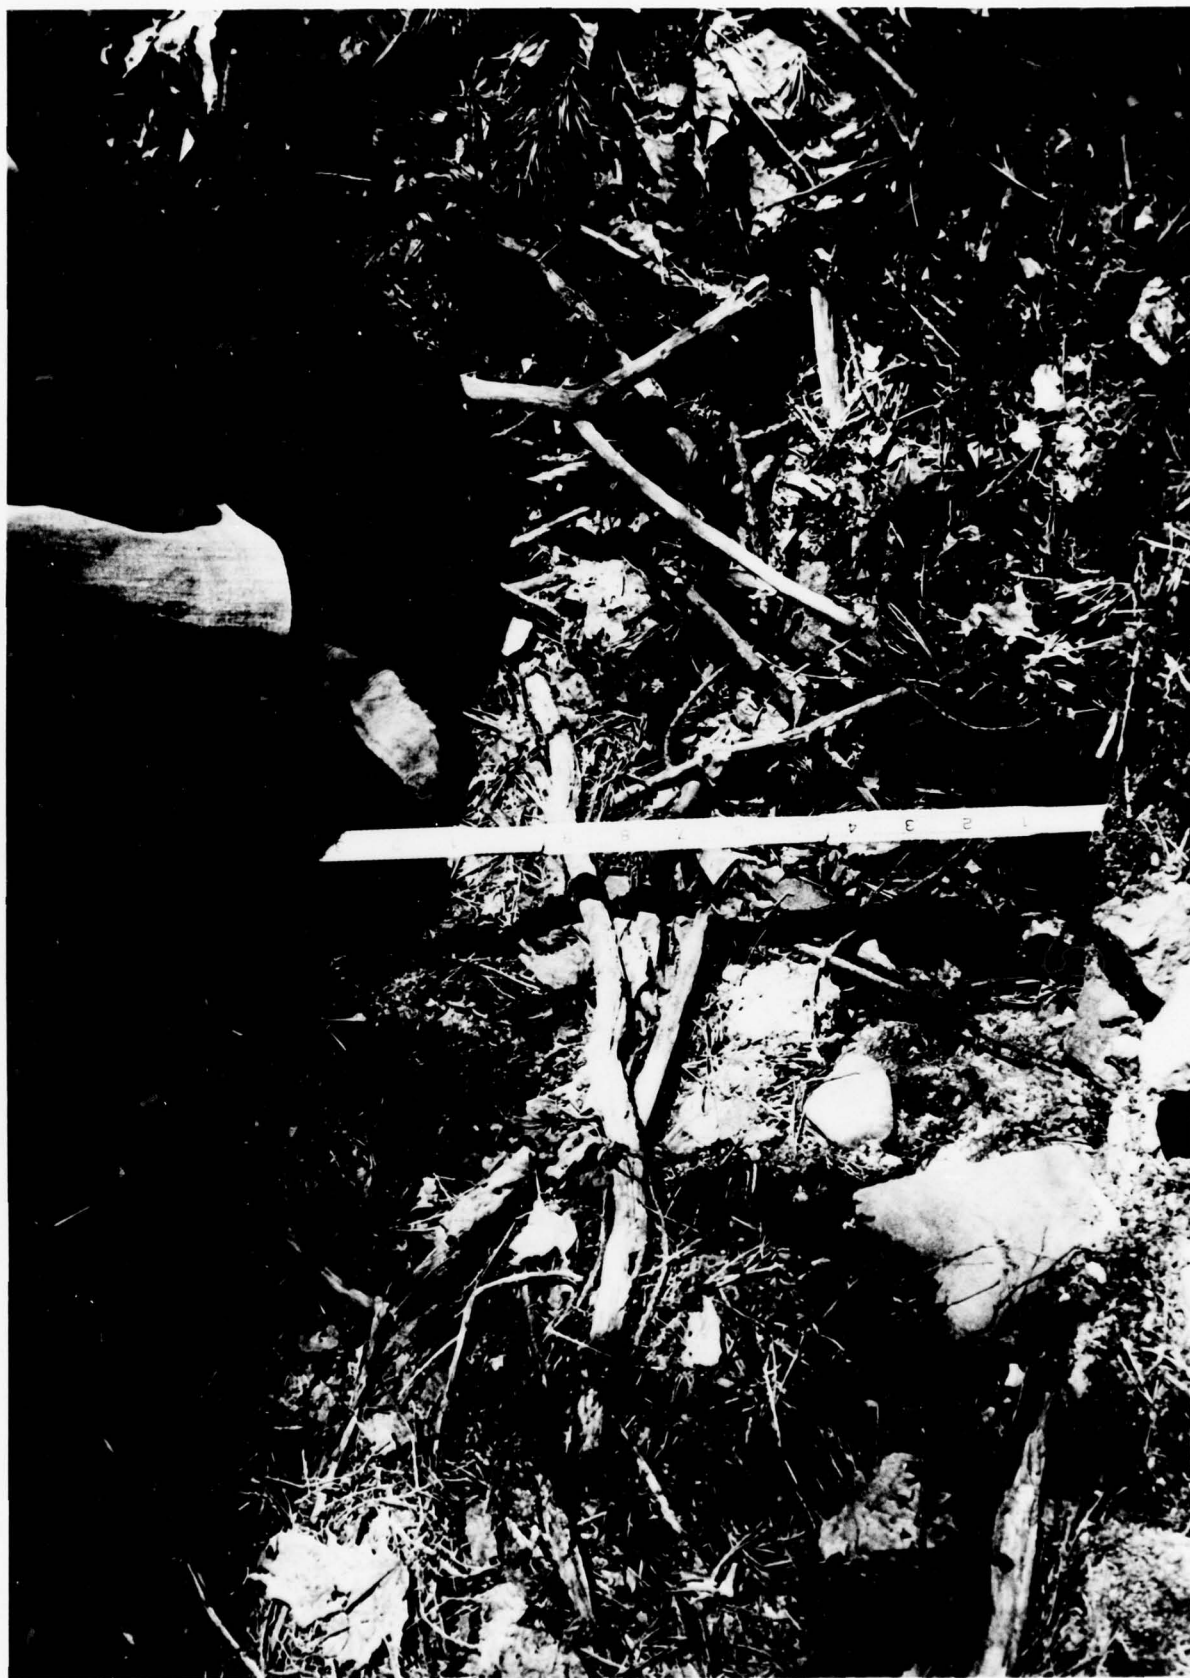
PLATE 8

8. Downstream of right abutment section, showing voids in rubble used as back fill.
